**U.S. ENVIRONMENTAL PROTECTION AGENCY--REGION VIII
SECTION 404 FIELD INVESTIGATION REPORT**

INSPECTOR: Richard Clark		DATE: May 30, 2013	TIME: 11:30 am
REASON FOR INSPECTION <input checked="" type="checkbox"/> Suspected Unpermitted Discharge (initial inspection) Source/Method of Discovery (name & telephone #): <input type="checkbox"/> Repeat Inspection for Verification of Elements of Violation <input type="checkbox"/> Review of Compliance with AO, Consent Decreed (CD) <input type="checkbox"/> Other:			
SITE LOCATION		Township: 15	
State: Wyoming			
County: Uinta		Range: 115	
Nearest Town: Fort Bridger		Section: 30	
Latitude: 41 Deg 15 Min 6.3 Sec North		Longitude: 110 Deg 25 Min 10.3 Sec West	
USGS/NWI Map Name:			
Name of Water Body or Adjacent Water Body and Description of Work Location: The unauthorized fill occurred in Nine Mile Creek which flows into Black Fork River, which flows into the Flaming Gorge Reservoir. Violation occurred near the town of Fort Bridger, Uinta County, Wyoming.

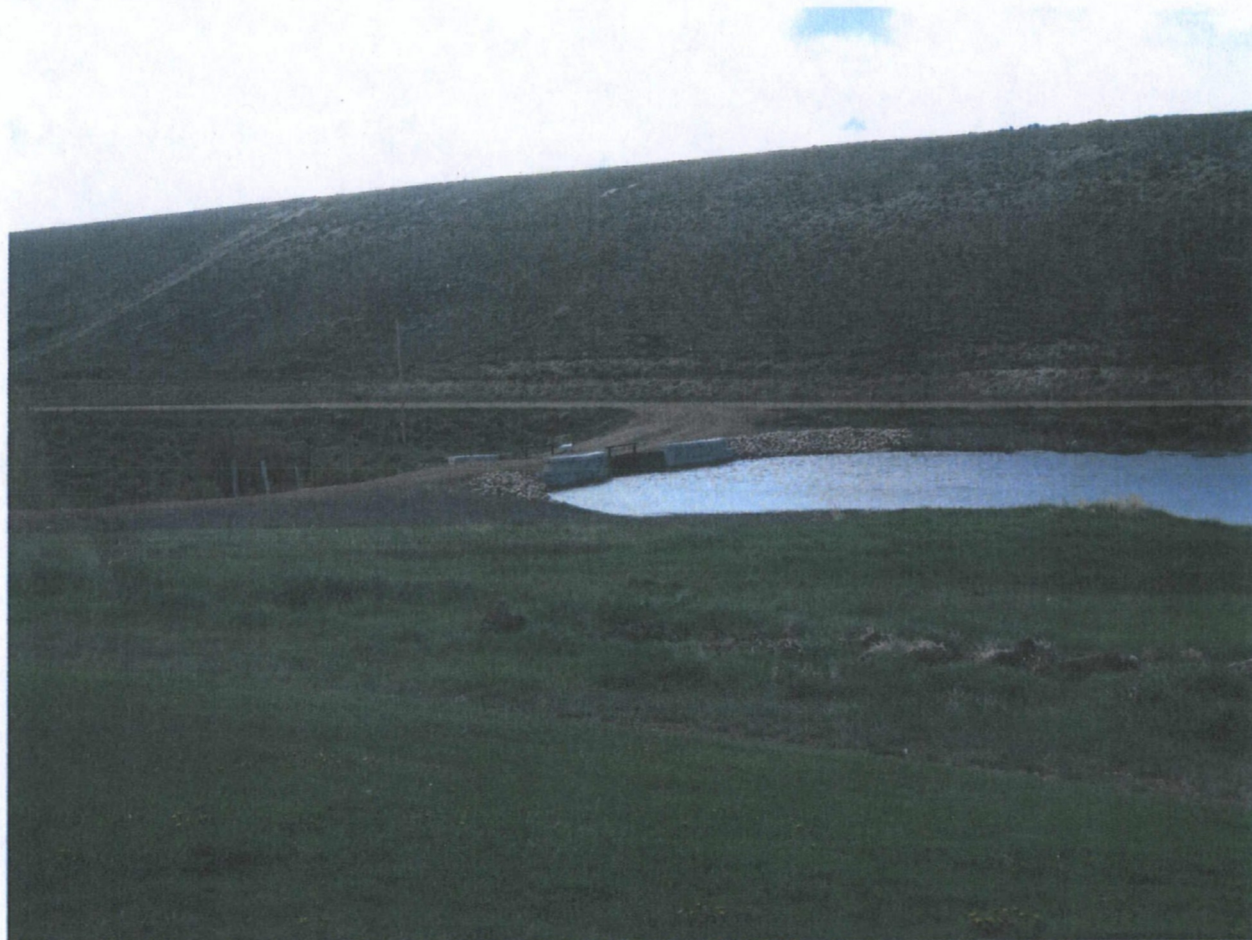
Photo 1: Taken May 30, 2013

Photo of the existing unpermitted dam. Looking in north east direction.

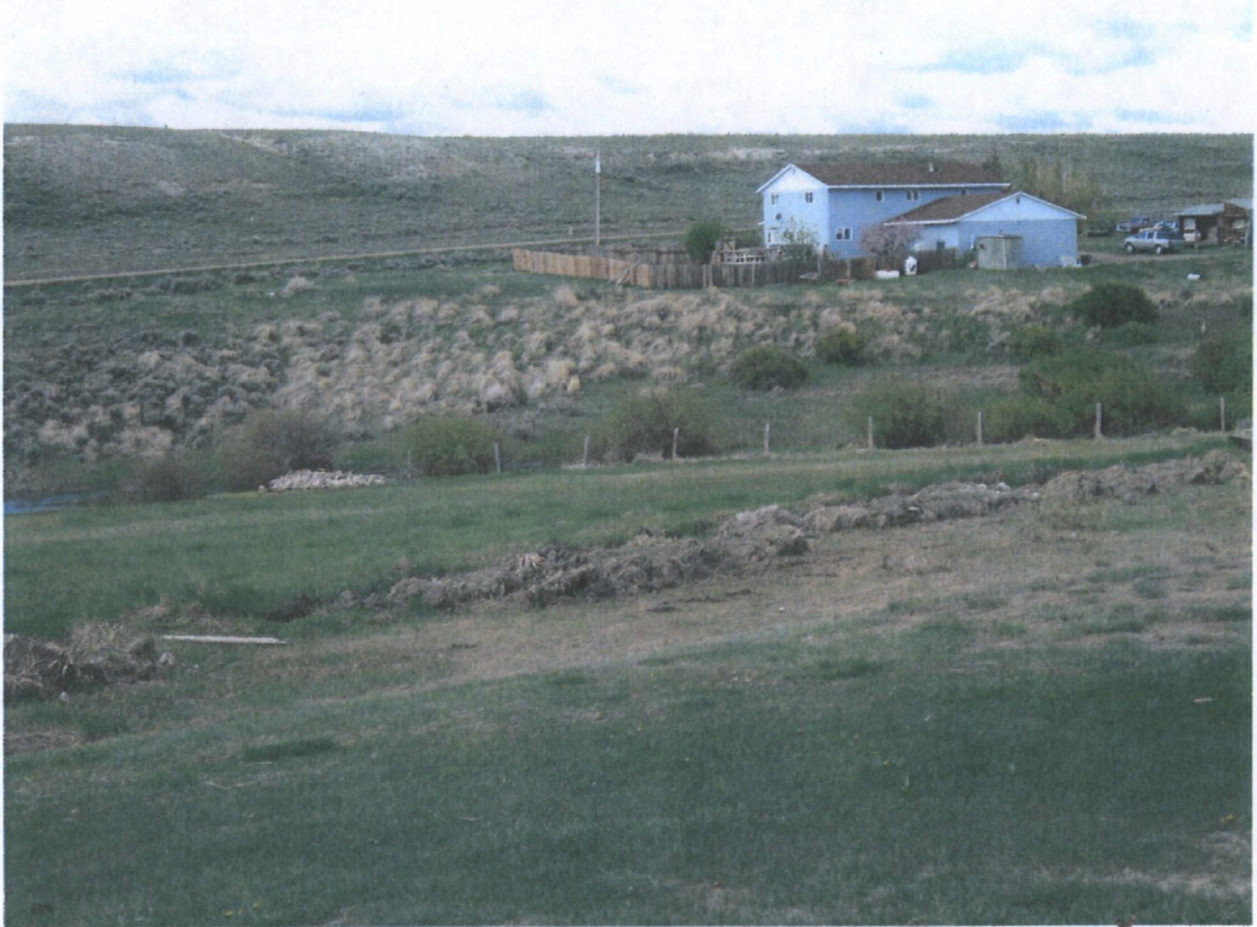
Photo 2: Taken May 30, 2013

Photo shows the upstream limit of the impounded water. House in the picture is Mr. Johnson's closest neighbor upstream of the dam. (Ms. Ann Rose). The fence in the middle of the photo is the property line between Mr. Johnson's property and Ms. Rose's

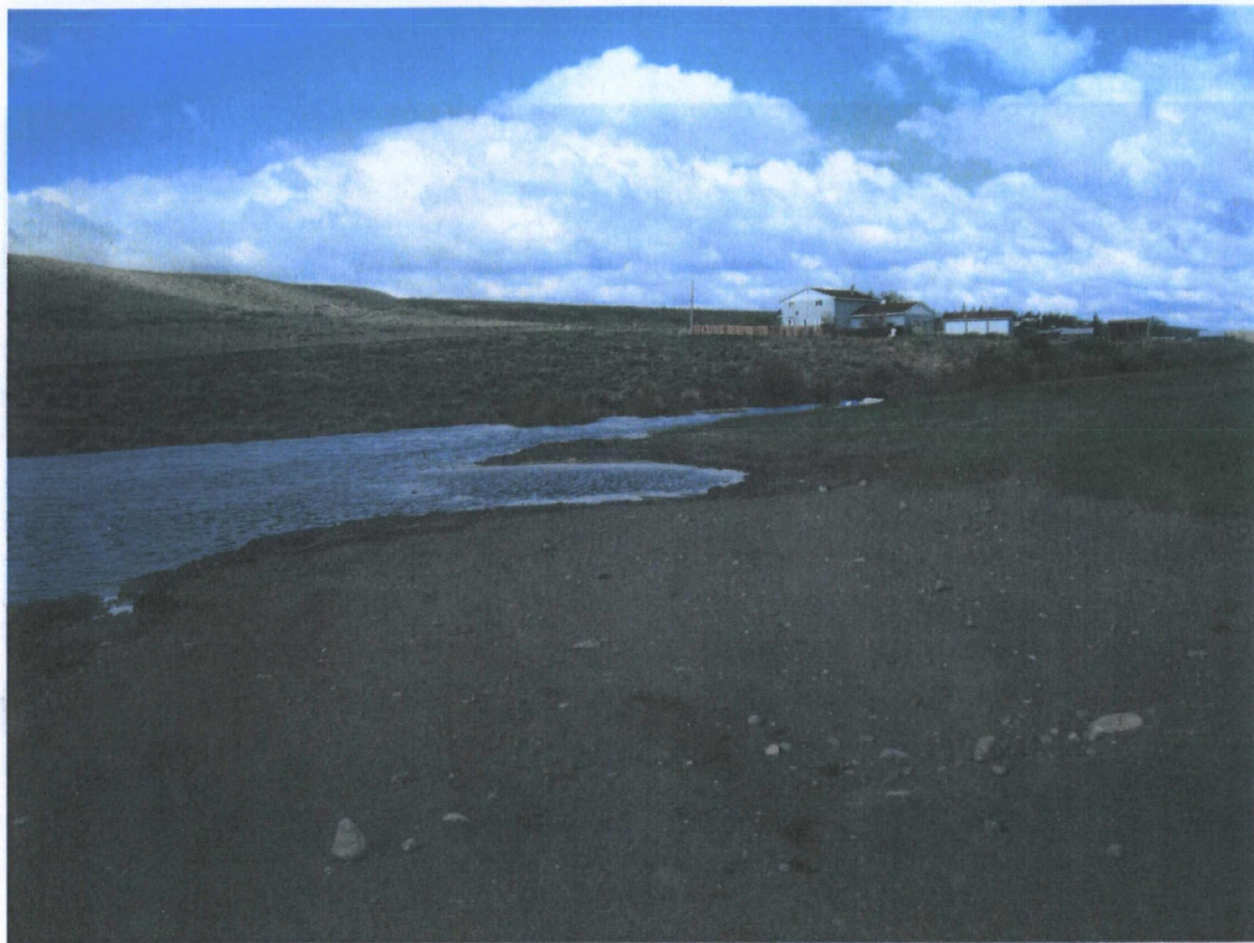
Photo 3: Taken May 30, 2013

Photo shows the upstream limit of the impounded water. House in the picture is Mr. Johnson's closest neighbor upstream of the dam. (Ms. Ann Rose).

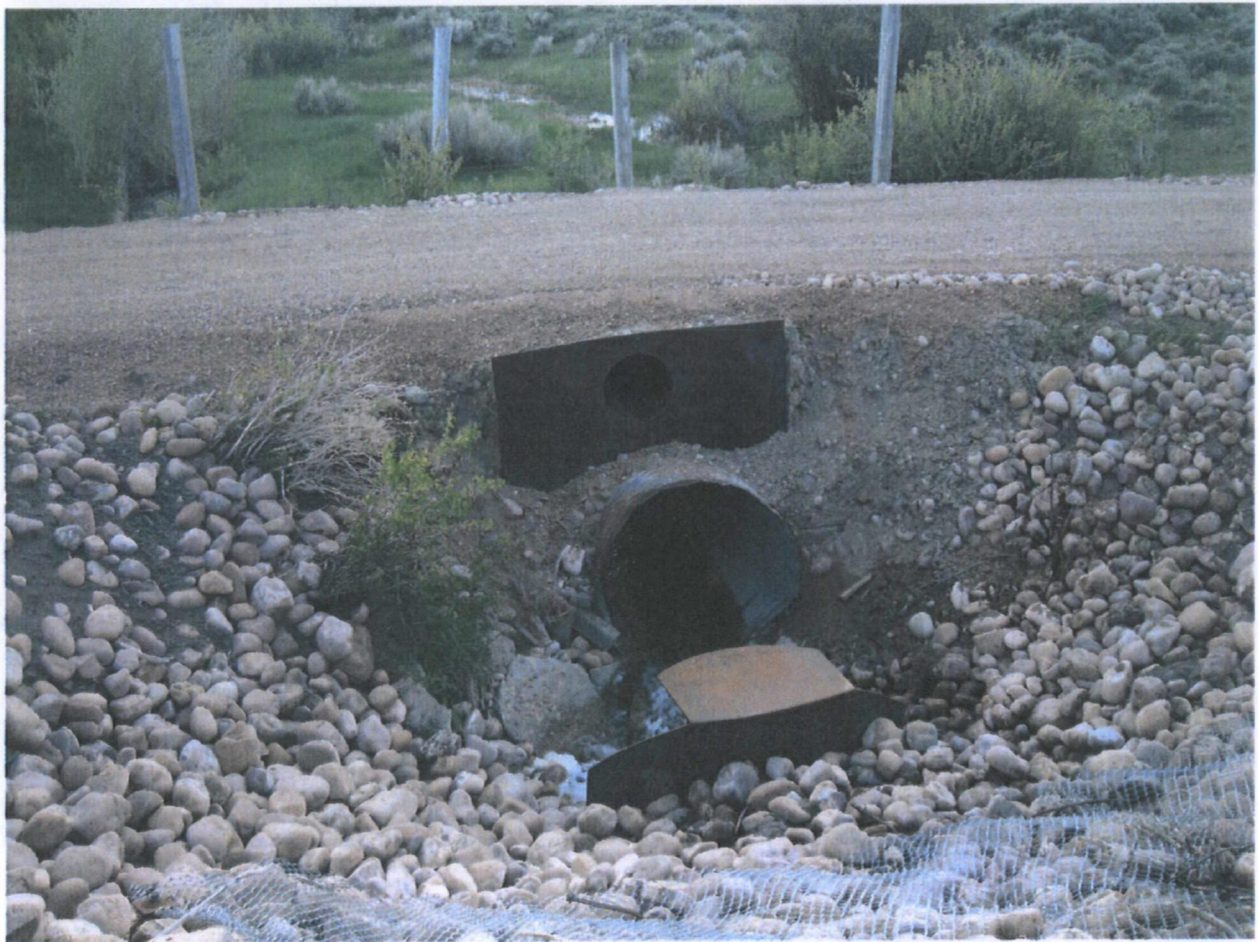
Photo 4: Taken May 30, 2013

Photo taken from top of dam looking downstream. The culverted road in the photo is the Uinta County road easement. This access is used by Mr. Jeffery Short to access his home. Mr. Short's property abuts Mr., Johnson property on the northern property line of Mr. Johnson's property.

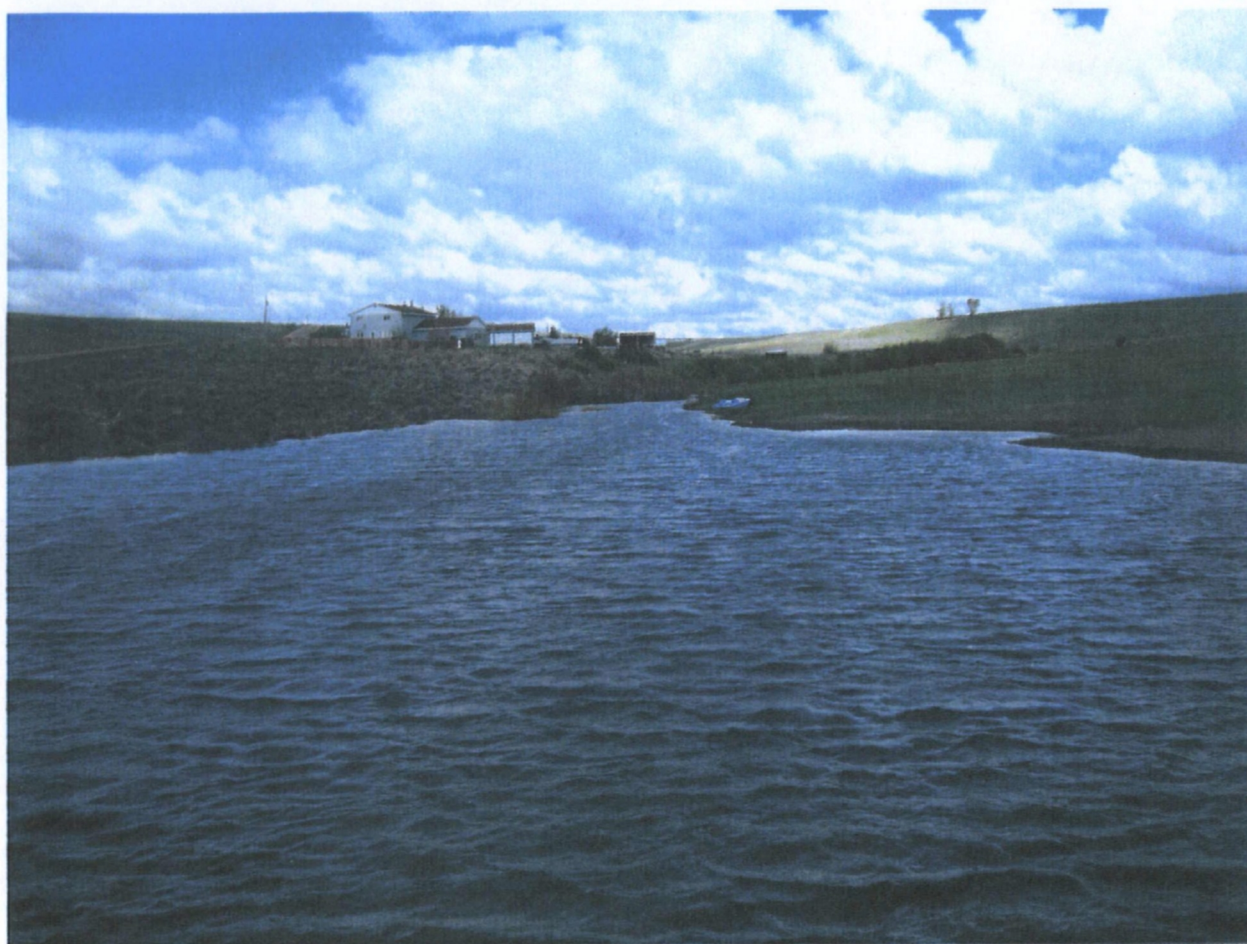
Photo 5: Taken May 30, 2013

Photo shows the upstream limit of the impounded water. House in the picture is Mr. Johnson closest neighbor upstream of the dam. (Ms. Ann Rose).
